DAMAGE PROFILES IN SILICON AND THEIR IMPACT ON
DEVICE RELIABILITY

G. H. Schwuttke

International Business Machines Corporation

TECHNICAL REPORT No. 7, Part I
January 1976

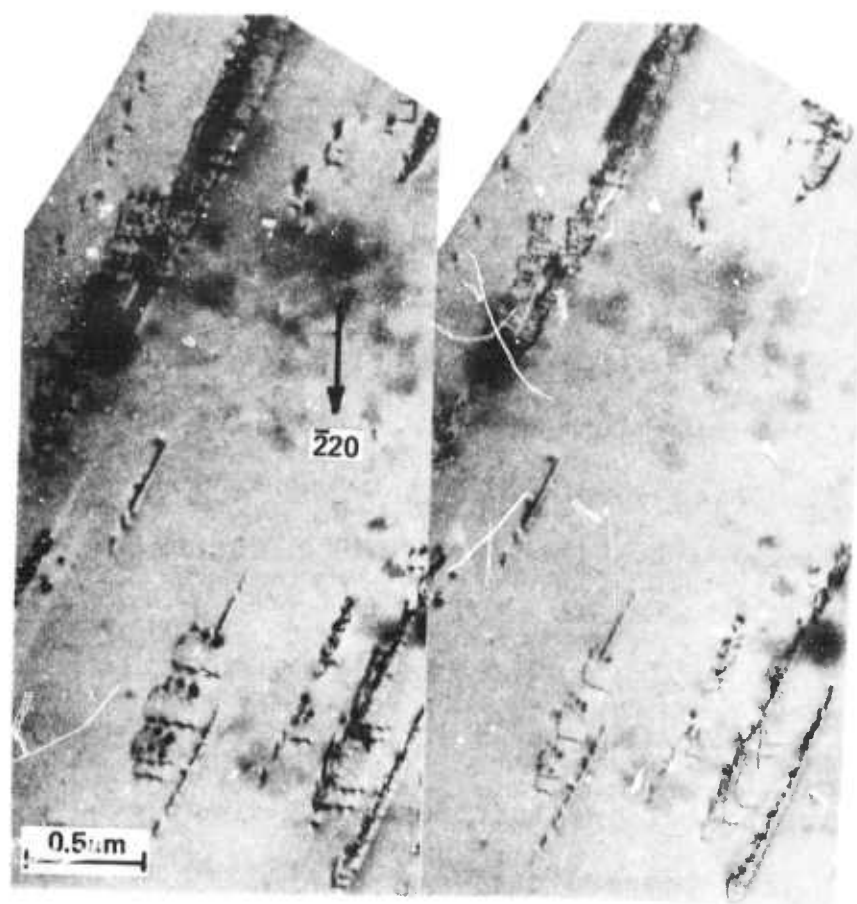
Fig. 12. Stereo set of dislocation loops for slip plane analysis.

This type of ISS damage on silicon surface is responsible for dislocation bands. A typical example is given in Fig. 11. Such dislocation bands are composed of dislocation loops and appear in rows oriented along $\langle 100 \rangle$, $\langle 110 \rangle$ or $\langle 120 \rangle$ directions (Fig. 1a). However, the intersections of all loops with the (001) surface is always a $\langle 110 \rangle$ direction indicating that the loops are located on (111) glide planes. Stereo-micrographs of such dislocation bands are given in Figs. 12 and show loops in (111) and ($\bar{1}\bar{1}\bar{1}$) planes.

More insight into the structure of the shear loop is obtained through determining the position of the extra lattice plane characteristic for this defect. The position of the extra lattice plane connected with a shear loop can be determined from its diffraction contrast observed in the electron microscope. Such techniques are described by Hirsch et al.⁷, and by Amelincks.⁸ We have applied this procedure to determine the nature of the dislocation loop. Such measurements are shown in Figs. 15a, b and 15c, d. According to these results, the displacement of the loop image in a micrograph is clearly seen by comparing the width of two specific loops in the set of micrographs recorded with $g = \pm (2\bar{2}0)$ (Fig. 15a, b) or recorded with $g = \pm (220)$ (Fig. 15c, d). By knowing the Burgers vector from the analysis described above and the loop habit plane obtained from the stereo set given in Fig. 12, the position of the pushed-in extra half plane can be evaluated.

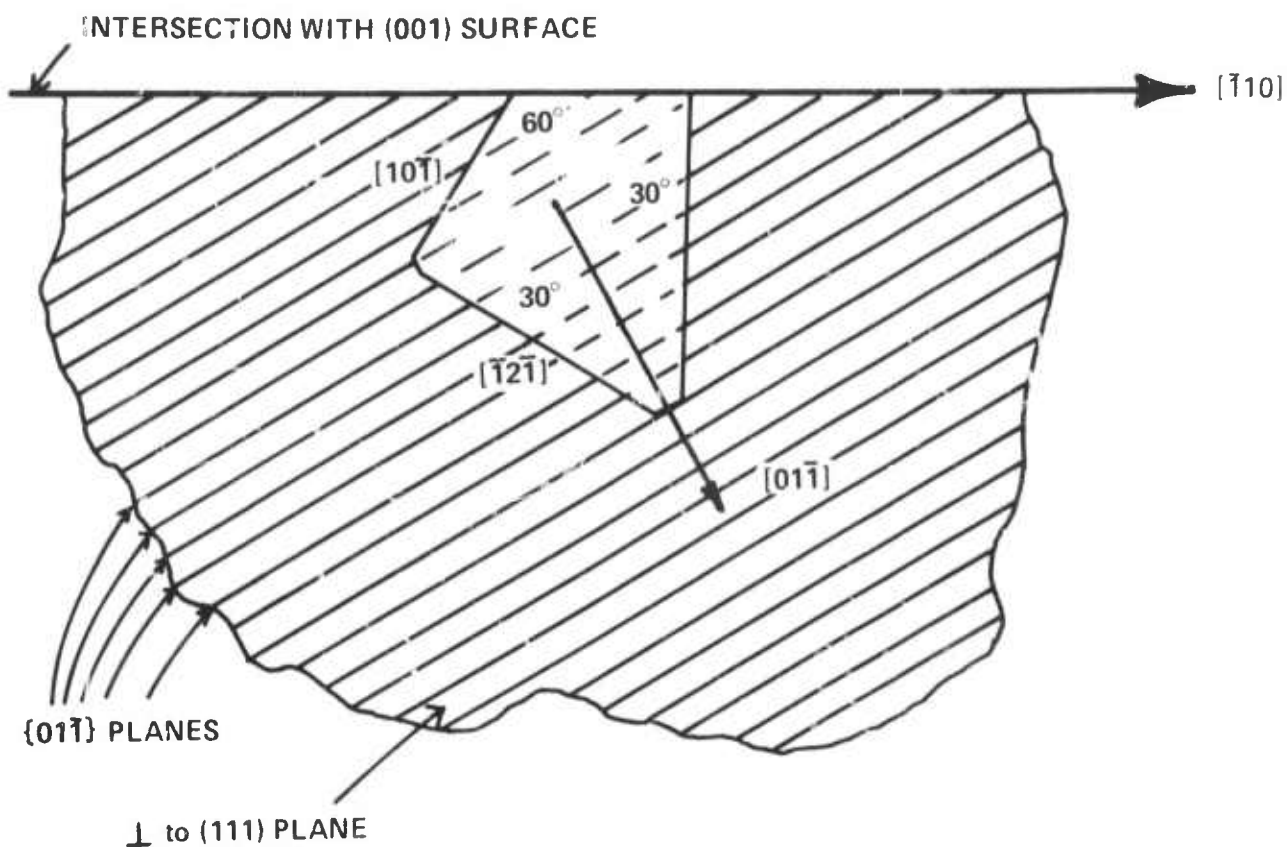
Fig. 13. Structure of shear loop. Loop expands in (111) loop plane and consists of 60° - and 30° - segments with Burgers vector along [011]. Analysis is based on micrographs of Fig. 14.

To understand the annealing properties of the dislocation bands Burgers vector determination of the dislocations are necessary. Such an analysis leads to the loop structure drawn schematically in Fig. 13.

The detailed loop structure shown in Fig. 13 is obtained from the analysis of several sets of TEM micrographs recorded for (400), (111) and (113) reflections (Fig.14). Accordingly, the Burgers vector of the loops is contained in the (111) or ($\bar{1}\bar{1}1$) plane with Burgers vector $(a/2)$ $[01\bar{1}]$ or $(a/2)[101]$. Consequently, these dislocations are mixed dislocation loops which lie and expand in the $\{111\}$ slip planes. Thus the loops are of the shear type.

The analysis indicates that the dislocation loops are due to extra half planes -- pushed in from the surface and positioned at the lowest point of the loop inside the crystal at the position where the two 30 degree dislocation segments meet (Fig. 13). Considering the damage mechanism -- tungsten balls hitting the surface -- this kind of damage, picturing a pushed-in lattice plane, appears plausible and appealing to naive expectation.

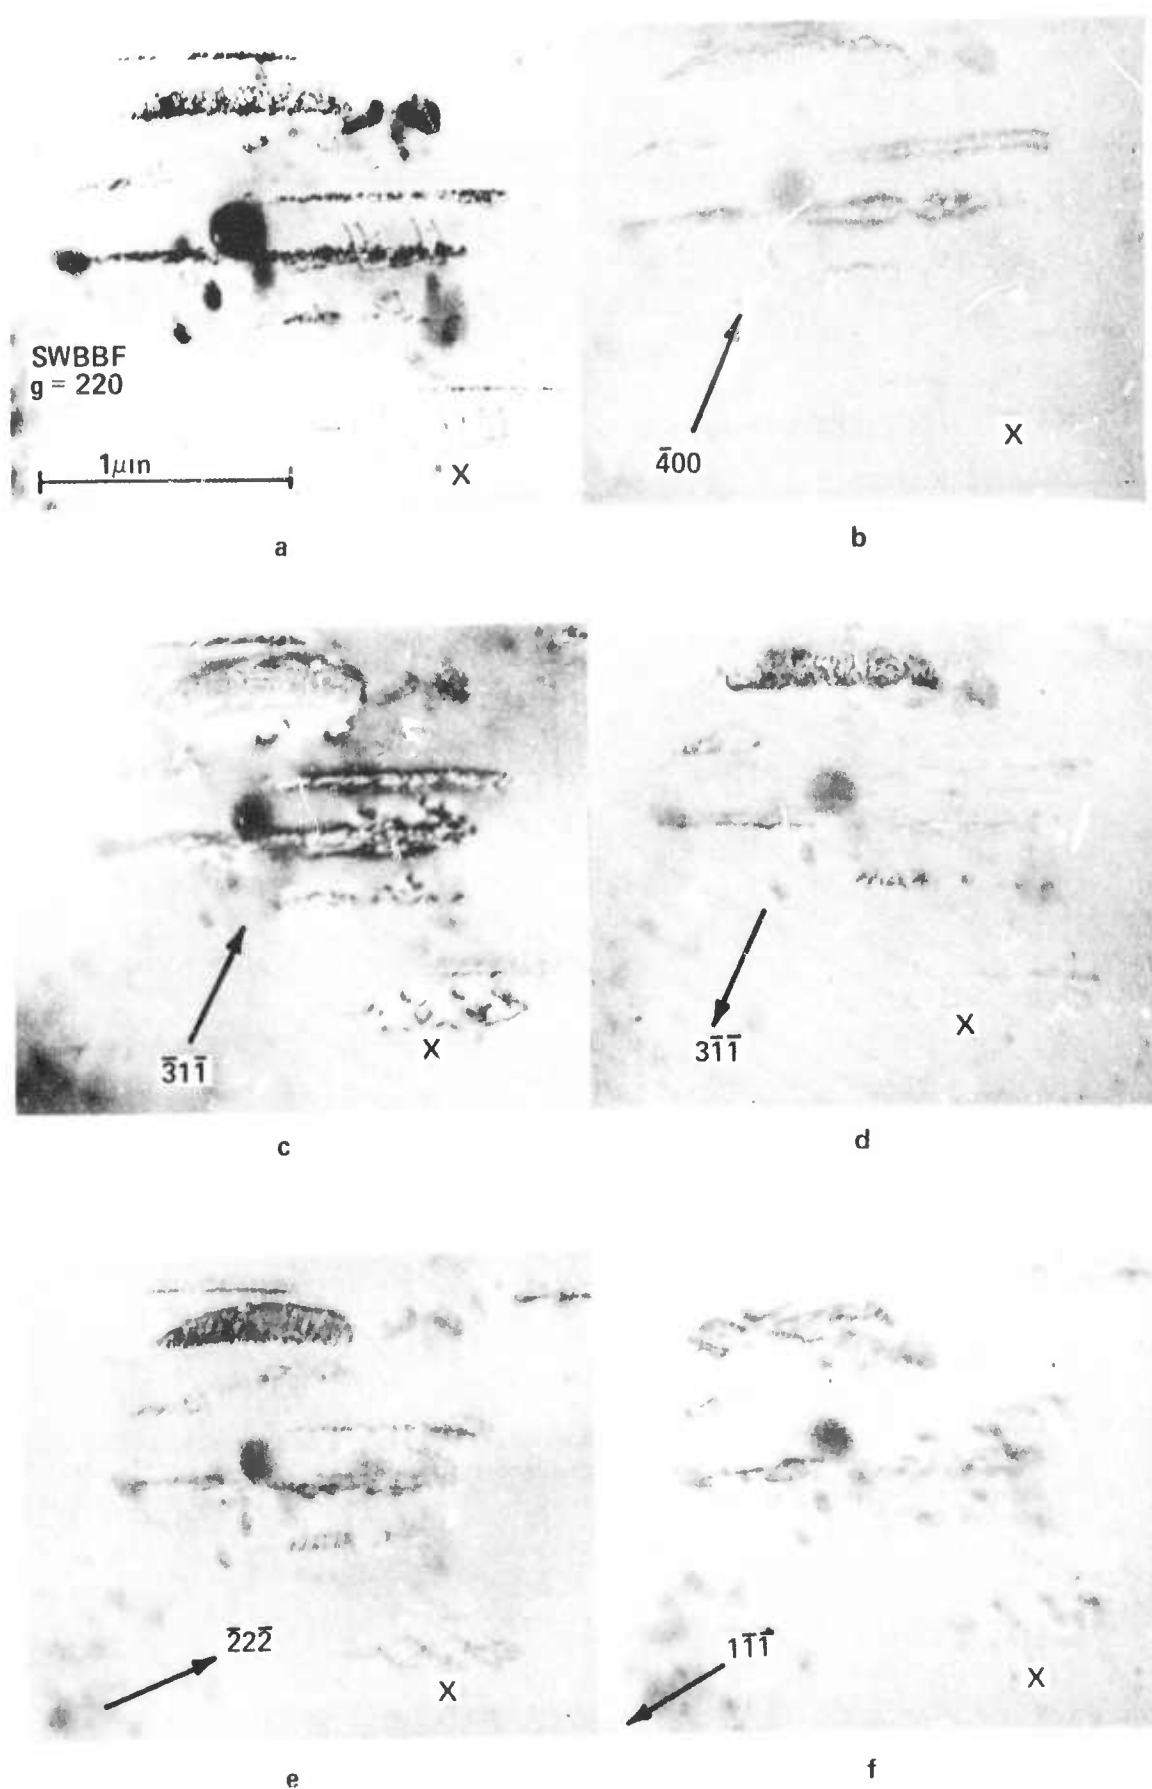
Fig. 14. Set of TEM micrographs taken in a Philips EM 301 with (a) SWBBF (220), (b) $\bar{4}00$, (c) $\bar{3}1\bar{1}$, (d) $\bar{3}1\bar{1}$, (e) $\bar{2}2\bar{2}$, (f) $1\bar{1}\bar{1}$ reflection.

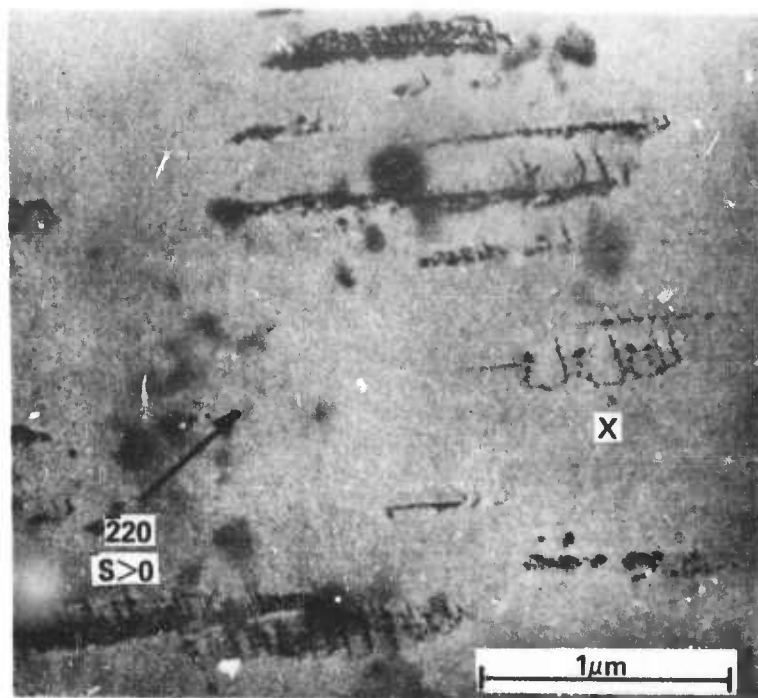
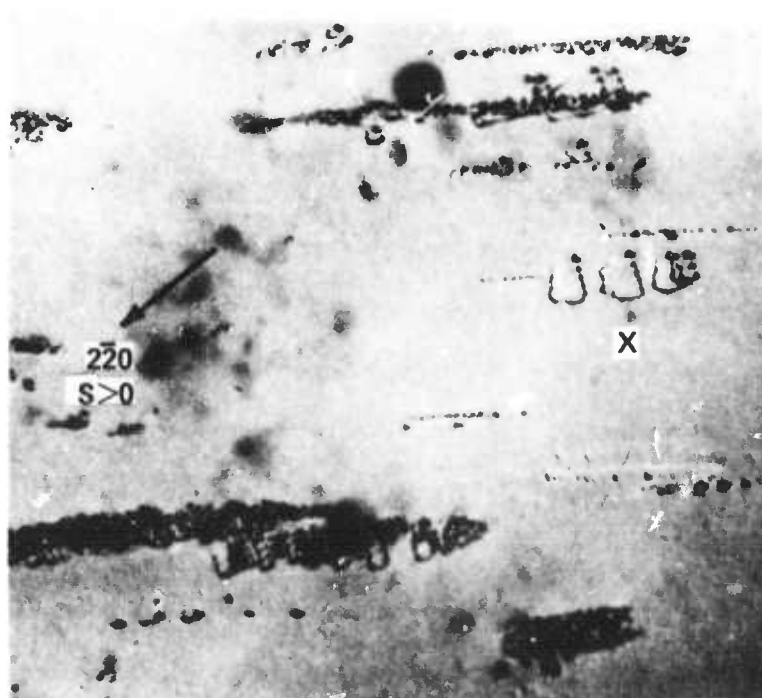
Fig. 15. TEM micrographs for determining the nature of dislocation loops. (a) $g = 220$, (b) $g = 2\bar{2}0$, excitation error $S > 0$.

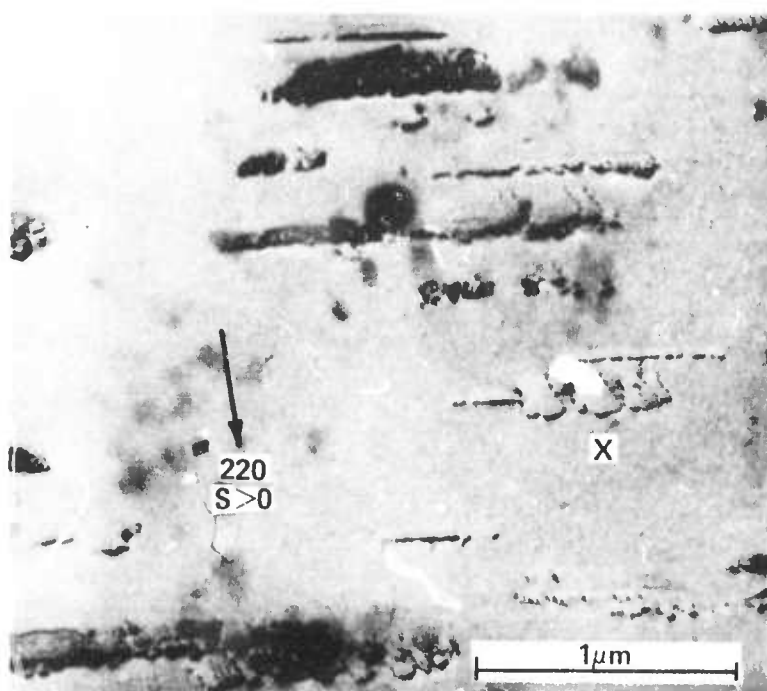
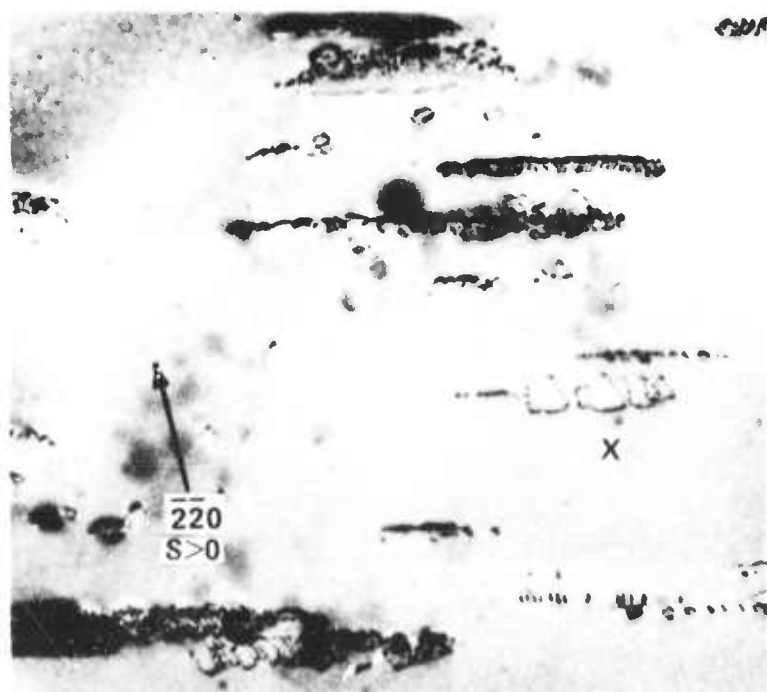
Fig. 15. TEM micrographs for determining the nature of dislocation loops.
(c) $g = 220$, (d) $g = \bar{2}20$.

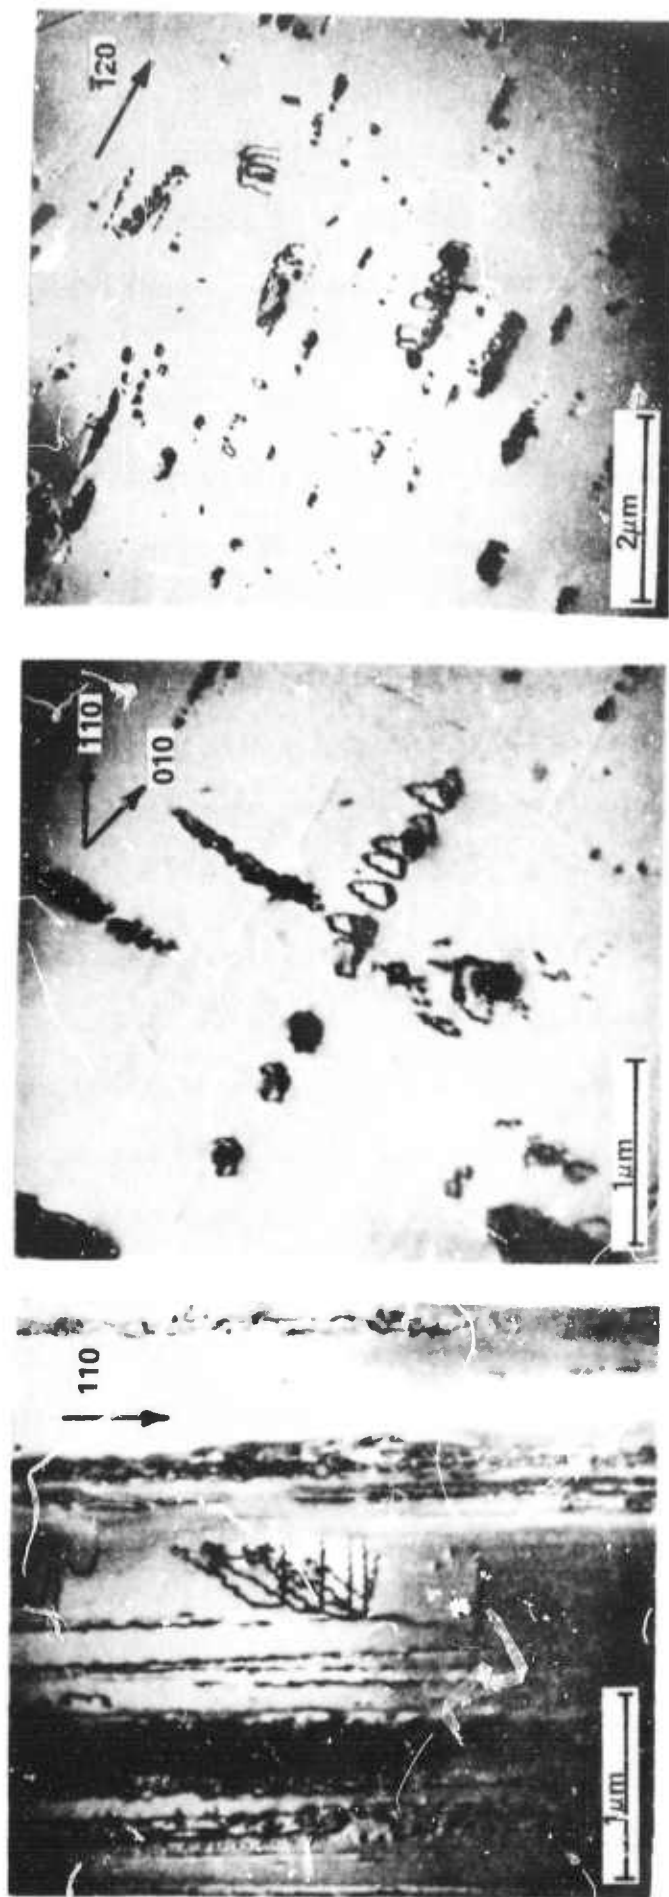
Fig. 16. TEM micrographs of abrasive damage (a) after surface abrasion and (b, c) ISS treatment, showing similarities and differences.

ISS groove damage is very similar to the abrasive damage normally encountered on wafer surfaces and is described and investigated in detail by Booker and Stickler². The TEM results in Fig. 16 compare abrasive damage produced by abrading a silicon surface unidirectionally with SiO₂ particles of 0.5 μm size in the <110> direction (Fig. 16a) with ISS damage (Figs. 16b,c). The difference between these two types

of damage is simply that the polishing damage is more dense and lined up in one direction while the ISS damage clusters can be considerably less dense but appear -- due to the randomness of the ball bouncing -- in several different directions.

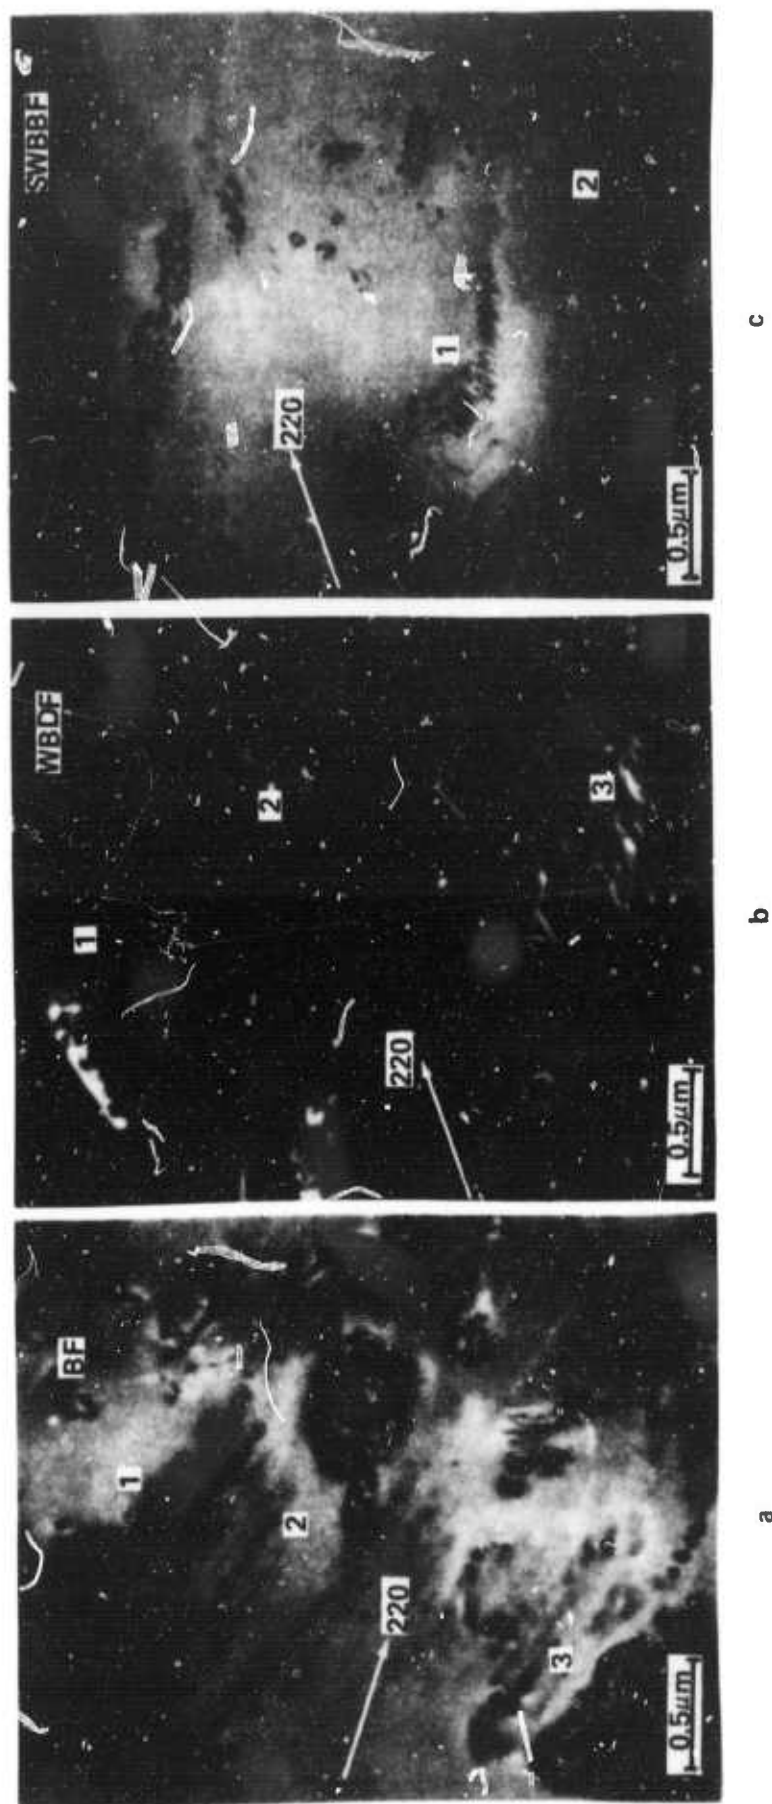
Fig. 17. Dislocation cluster areas taken with high resolution techniques in the TEM.
 (a) Usual bright field image (BF), (b) weak beam dark field image (WBDF),
 (c) symmetric weak beam bright field image (SWBBF).

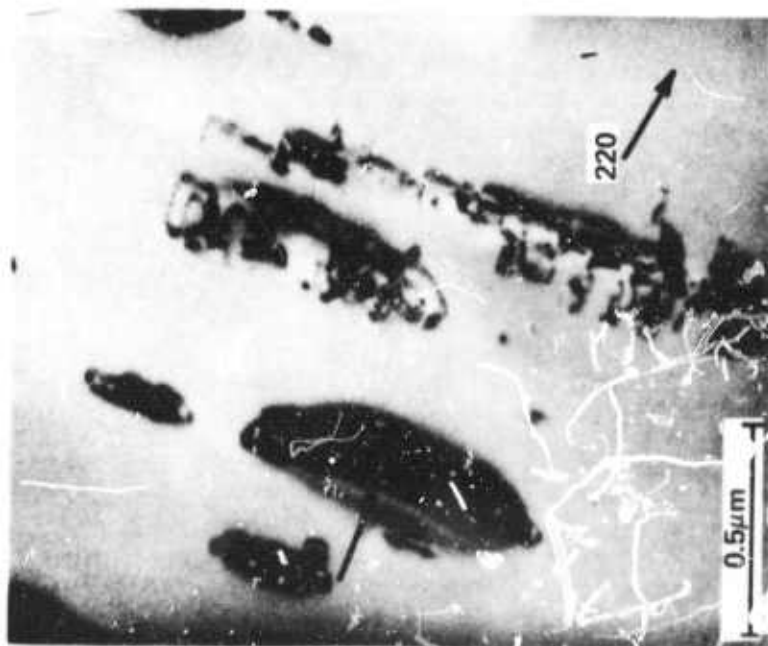
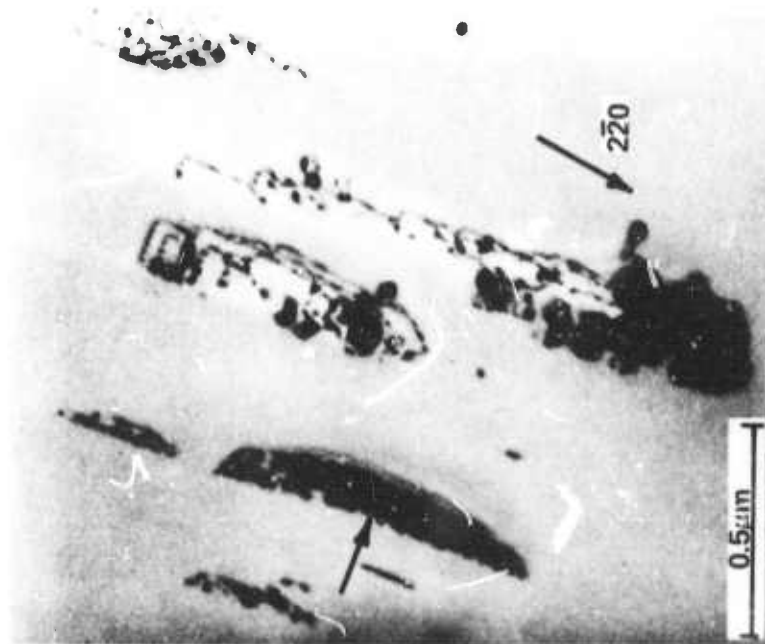
Fig. 18. $\text{WB}\bar{2}\bar{2}$ images of dislocation cluster areas where dislocations are piled up to a distance of about 200 Å so that small crack formation is possible. (a) $g = 220$, (b) $g = 2\bar{2}0$.

An additional result from such investigations is the finding that dislocation pile-ups are present on neighboring slip planes which are separated by only 200Å. (Fig. 18a,b,c,d). This is shown schematically in Fig. 18e. This would mean that such dislocation clusters

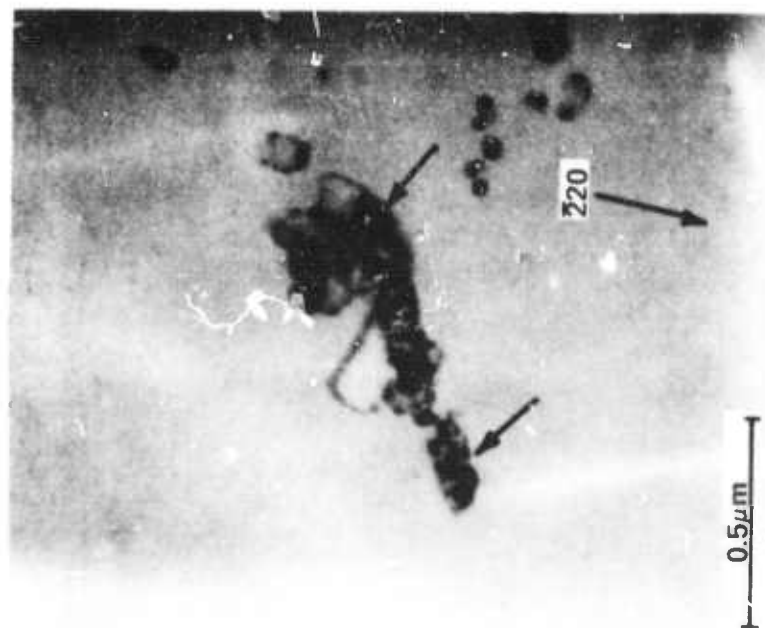
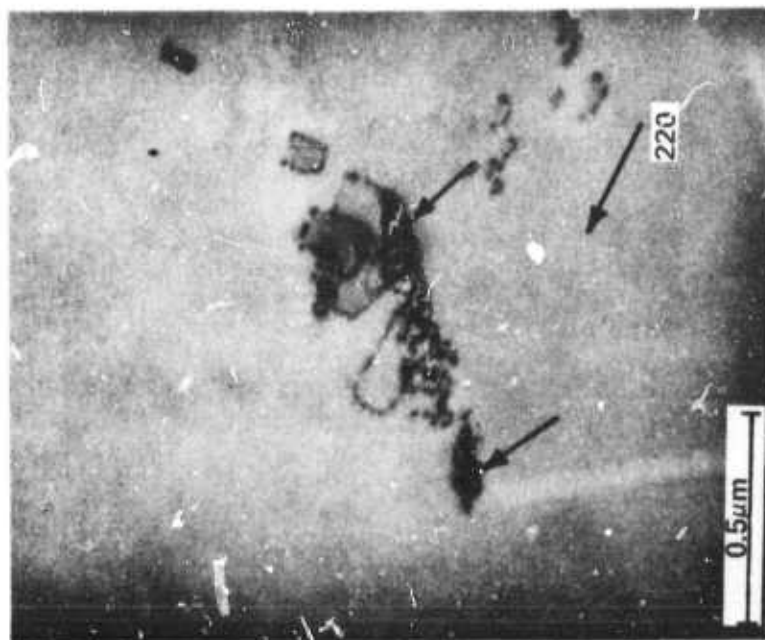
Fig. 18. SWBBF image of another dislocation cluster area. (c) $g = \bar{2}20$,
(d) $g = 220$.

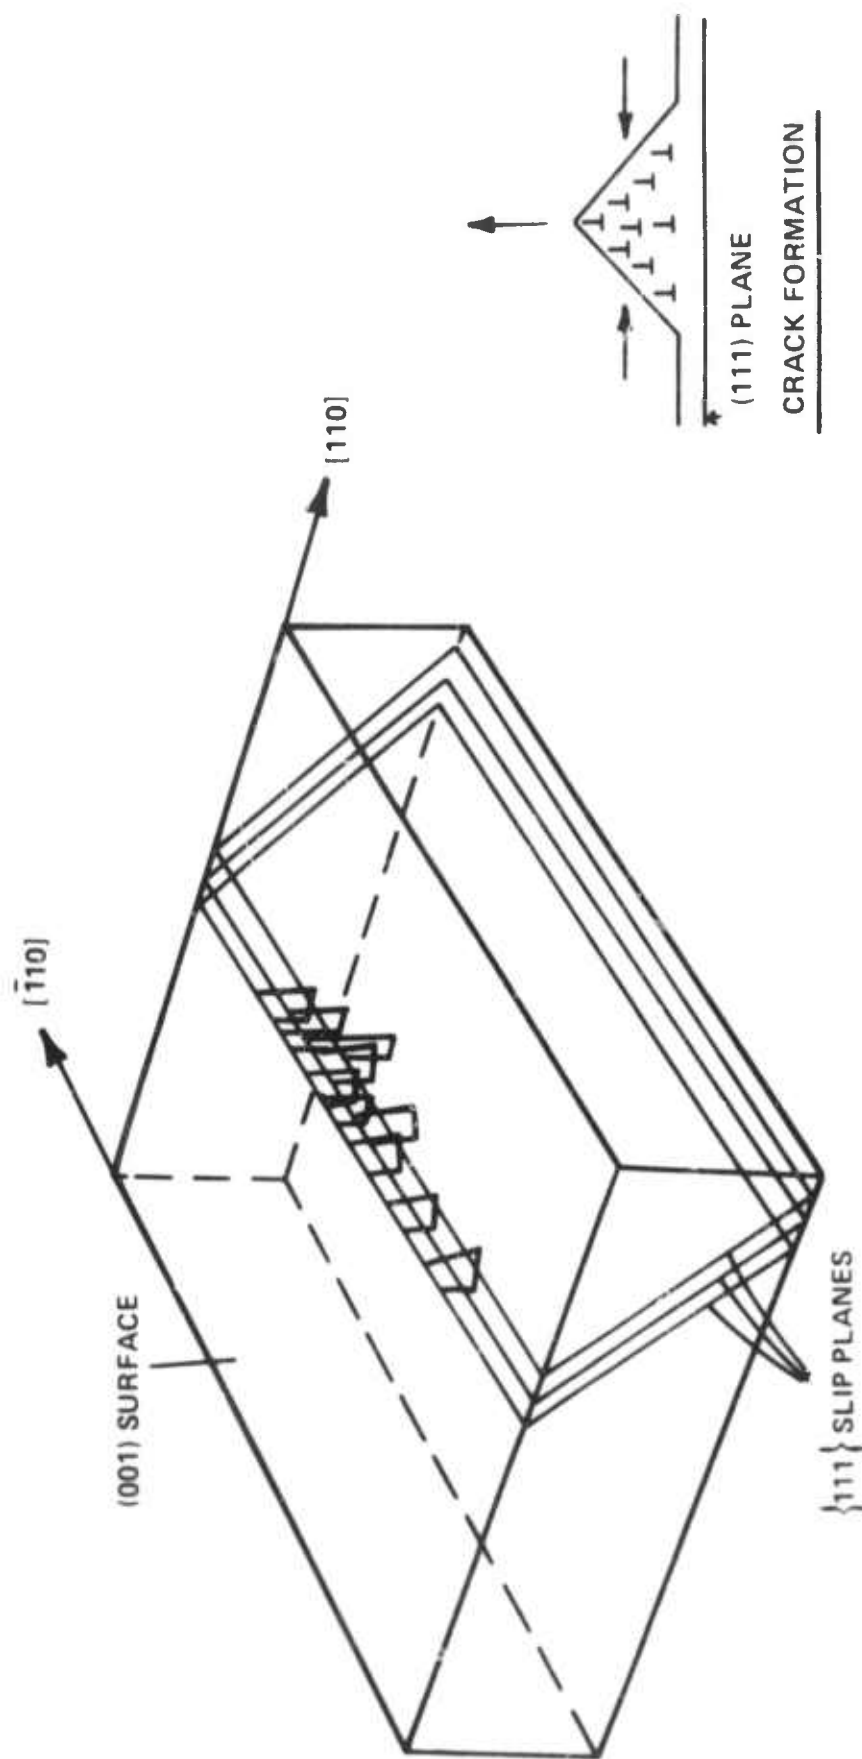
Fig. 18e. Schematic of dislocation pile-up formation.

contain dislocation pile-ups approximately 50 lattice planes apart. The corresponding dislocation density would be $10^{10}/\text{cm}^2$ or higher. Based on the work of Fujita¹⁰, Cottrell¹¹, and specifically of Abrahams and Ekstrom¹² such dense dislocation pile-ups favor microcrack formation. Consequently, we must assume that abrasive type of damage produces microcracks in silicon and this appears to be reasonable for a material as brittle as silicon at room temperature.

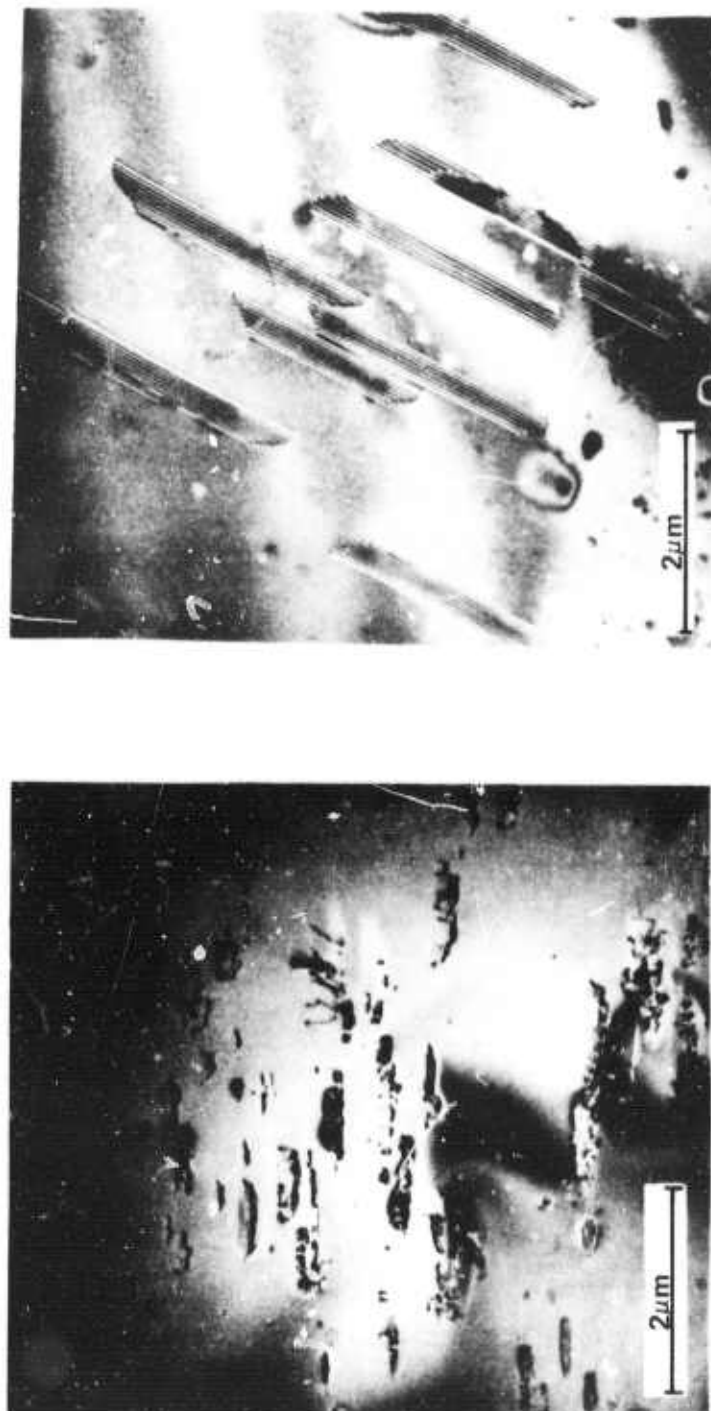
Fig. 19. TEM micrograph of Si wafer surface. (a) Immediately after sound stressing showing dislocation clusters; (b) after sound stressing and standard oxidation showing stacking faults. Density of faults is comparable to number of dense clusters in Fig. 19a.

Stacking faults are definitely nucleated at sites of high density damage clusters. This is clearly seen by comparing the TEM micrographs shown in Figs. 19a,b. The defect structure of the sample after ISS is seen

in Fig. 19a. An oxidation cycle anneals the low density dislocation clusters out of the samples while in the area of high density clusters stacking faults are nucleated* (Fig. 19b). The size of the stacking faults depends on the oxidation time.

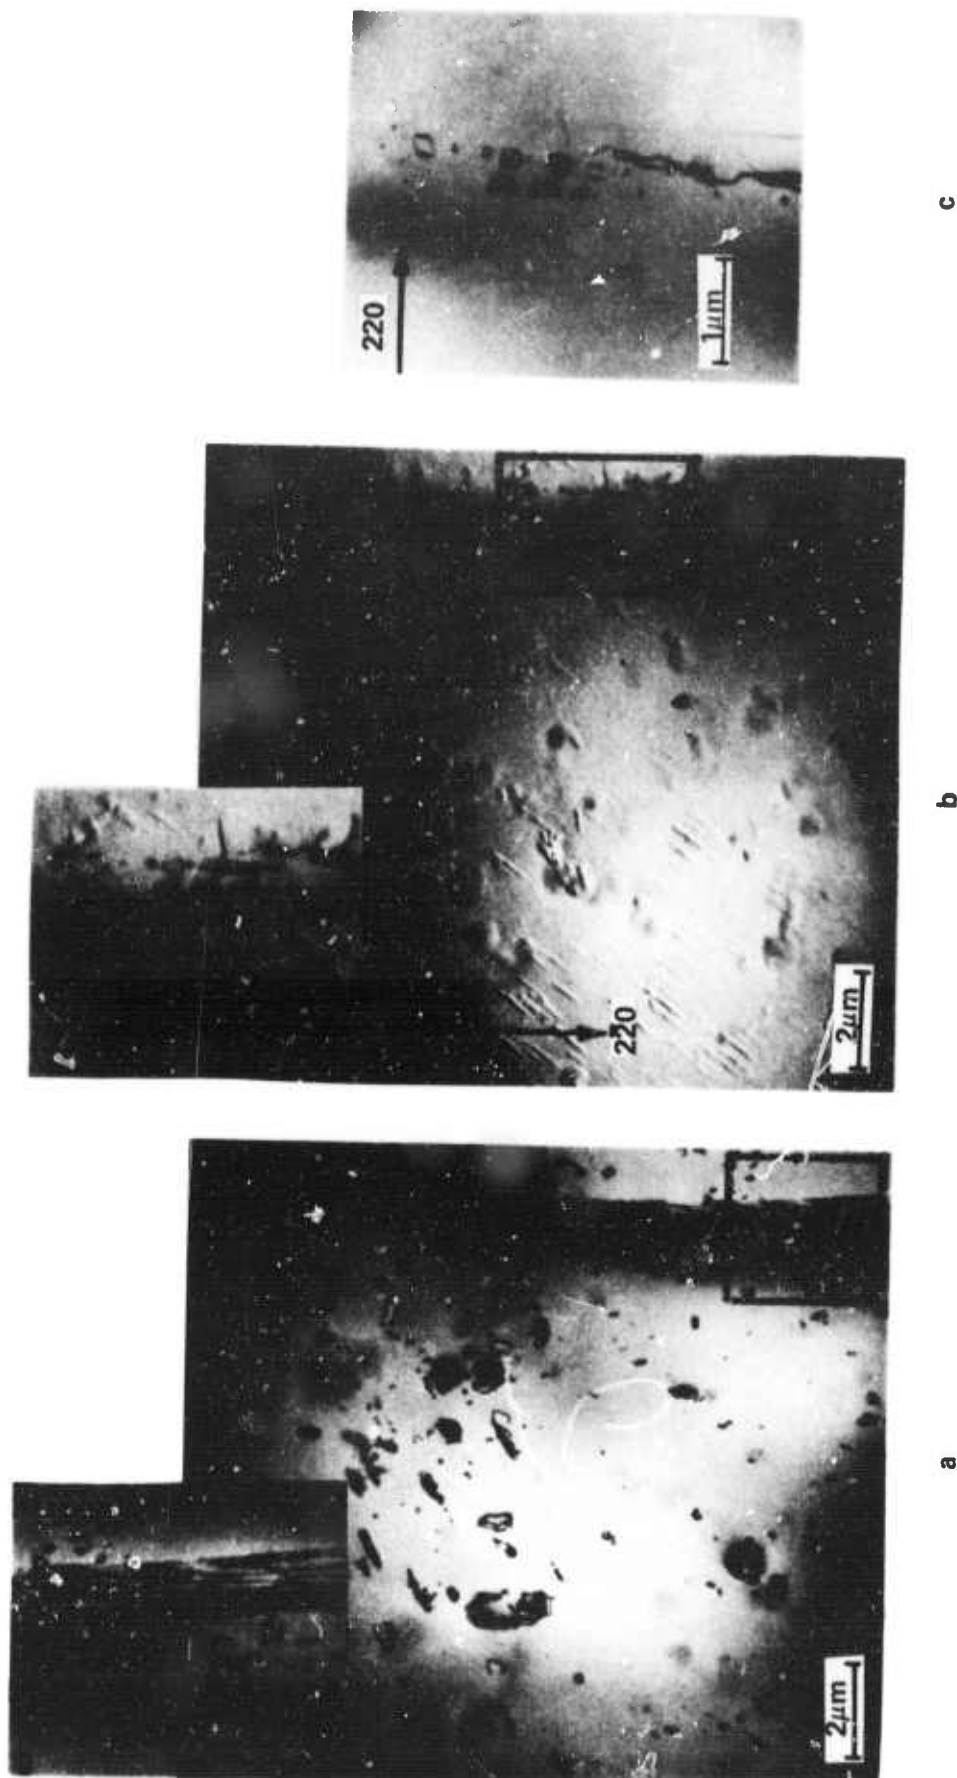
Fig. 20. TEM micrographs of Si wafer surface. (a) After sound stressing with dislocation loops, clusters and one microcrack; (b) after 10 min dry oxidation with the oxide film still on to show all the traces of the defects in (a); (c) after SiO_2 removal.

To obtain a one-to-one correlation between dislocation clusters and oxidation induced stacking faults we had to rely on the investigation made on "TEM specimens" before and after short time oxidations. Such samples were first completely "mapped" using TEM micrographs to ascertain the defect state after ISS. Subsequently, the samples were oxidized outside the microscope and re-inserted. Using short time dry oxidation steps the thin oxide film on the sample surface did not have to be removed for TEM investigation and thus supplied us with a "replica" of the original defect state (before oxidation) of the sample. The traces of practically all defects present before oxidation are found replicated in the thin oxide film. Examples are shown in Figs. 20 to 22.

In Fig. 20a it can be observed that most of the defects are annealed out even after a short 10 minute oxidation at 1050°C. In the area of the large crack in Fig. 20b, observed are dislocation lines, prismatic loops inside the crystal and stacking faults at the intersection of the crack and specimen surface. Figure 21 shows an example of a crack only partially annealed. A stacking fault is generated at the exact location of a dislocation cluster. A similar observation is made in Fig. 22 for a different sample.

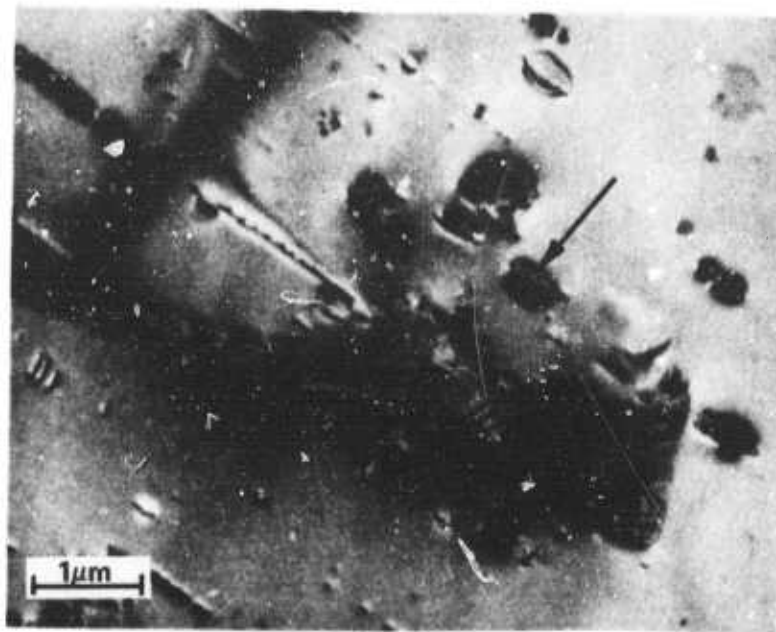
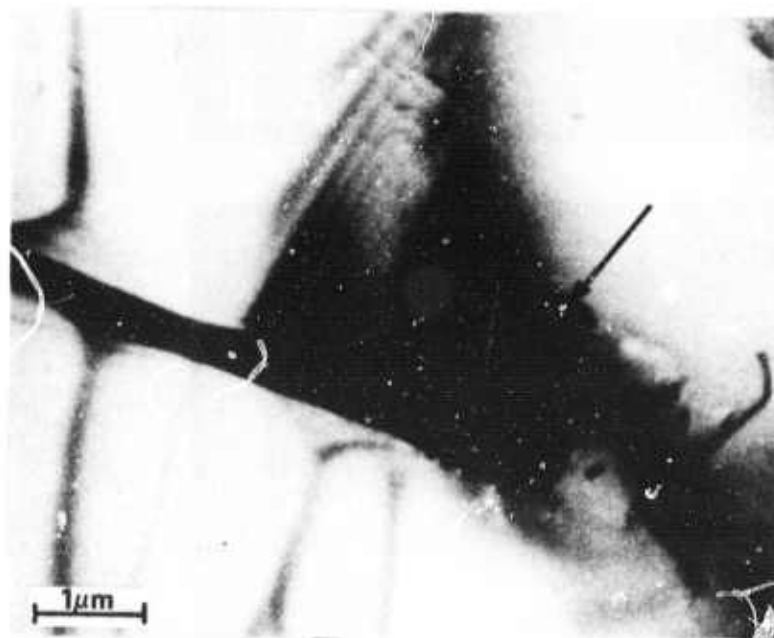
Fig. 21. TEM micrographs of Si wafer surface, (a) after sound stressing with dislocation loops, clusters and one microcrack; (b) after 10 min dry oxidation showing a stacking fault generated at a position of a cluster in (a).

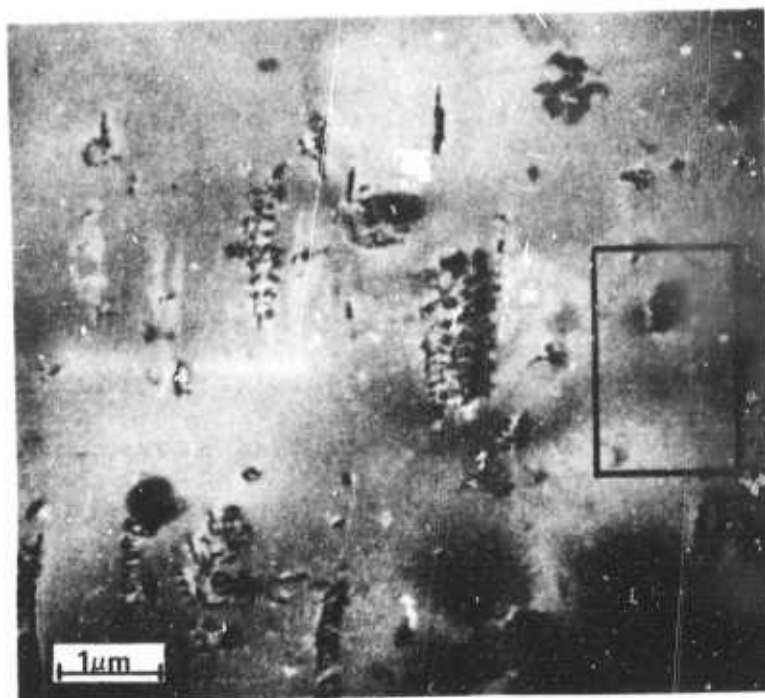
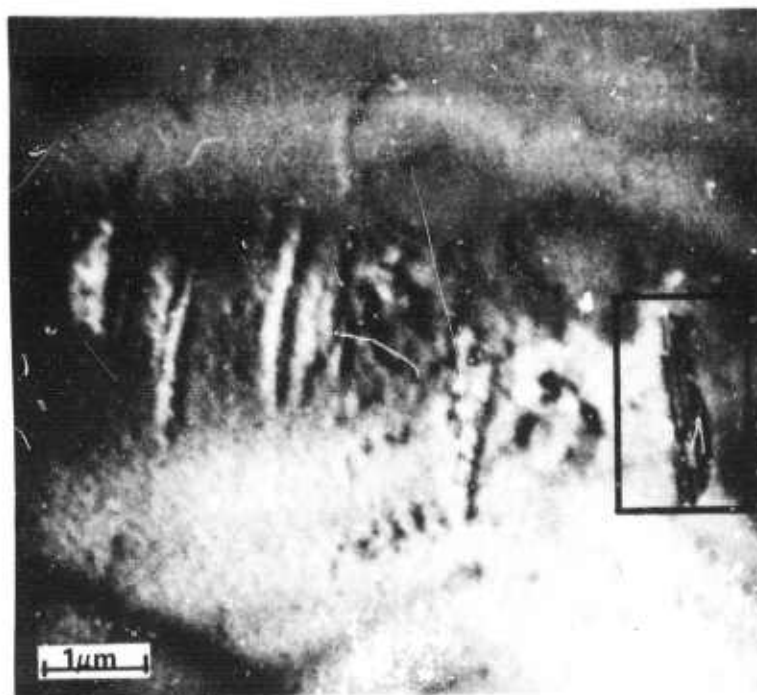
Fig. 22. Another example of one-to-one correlation of (a) cluster after ISS and (b) stacking faults after 10 min oxidation.

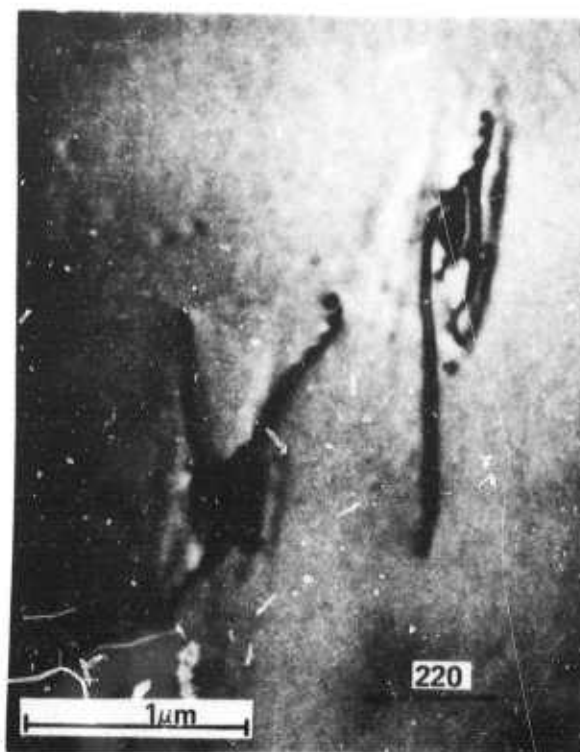
Fig. 23. TEM micrograph showing the simultaneous generation of stacking faults and 90° and 60° dislocation after 10 min dry oxidation at 1050°C of a sound stressed wafer surface.

In several samples stacking faults as well as 90°- and 60°- dislocations were generated after 10 minute dry oxidation at 1050°C within the area corresponding to a high density dislocation cluster mixed with small cracks (Fig. 23). No indication is found that such 90°- dislocation dissociate into a stacking fault bounded by Frank and Shockley partials. Such a dislocation reaction is possible according to the equation: $\frac{1}{2}(110) \rightarrow \frac{1}{3}(111) + \frac{1}{6}(11\bar{2})$. However, this reaction was not verified experimentally.

outcome of such a reaction is a perfect dislocation (90 degree Burgers vector). Such dislocations are indicated in the micrographs presented in Fig. 24. Accordingly the dislocations presented in Fig. 23 are identified as annealing products of intersecting stacking faults.

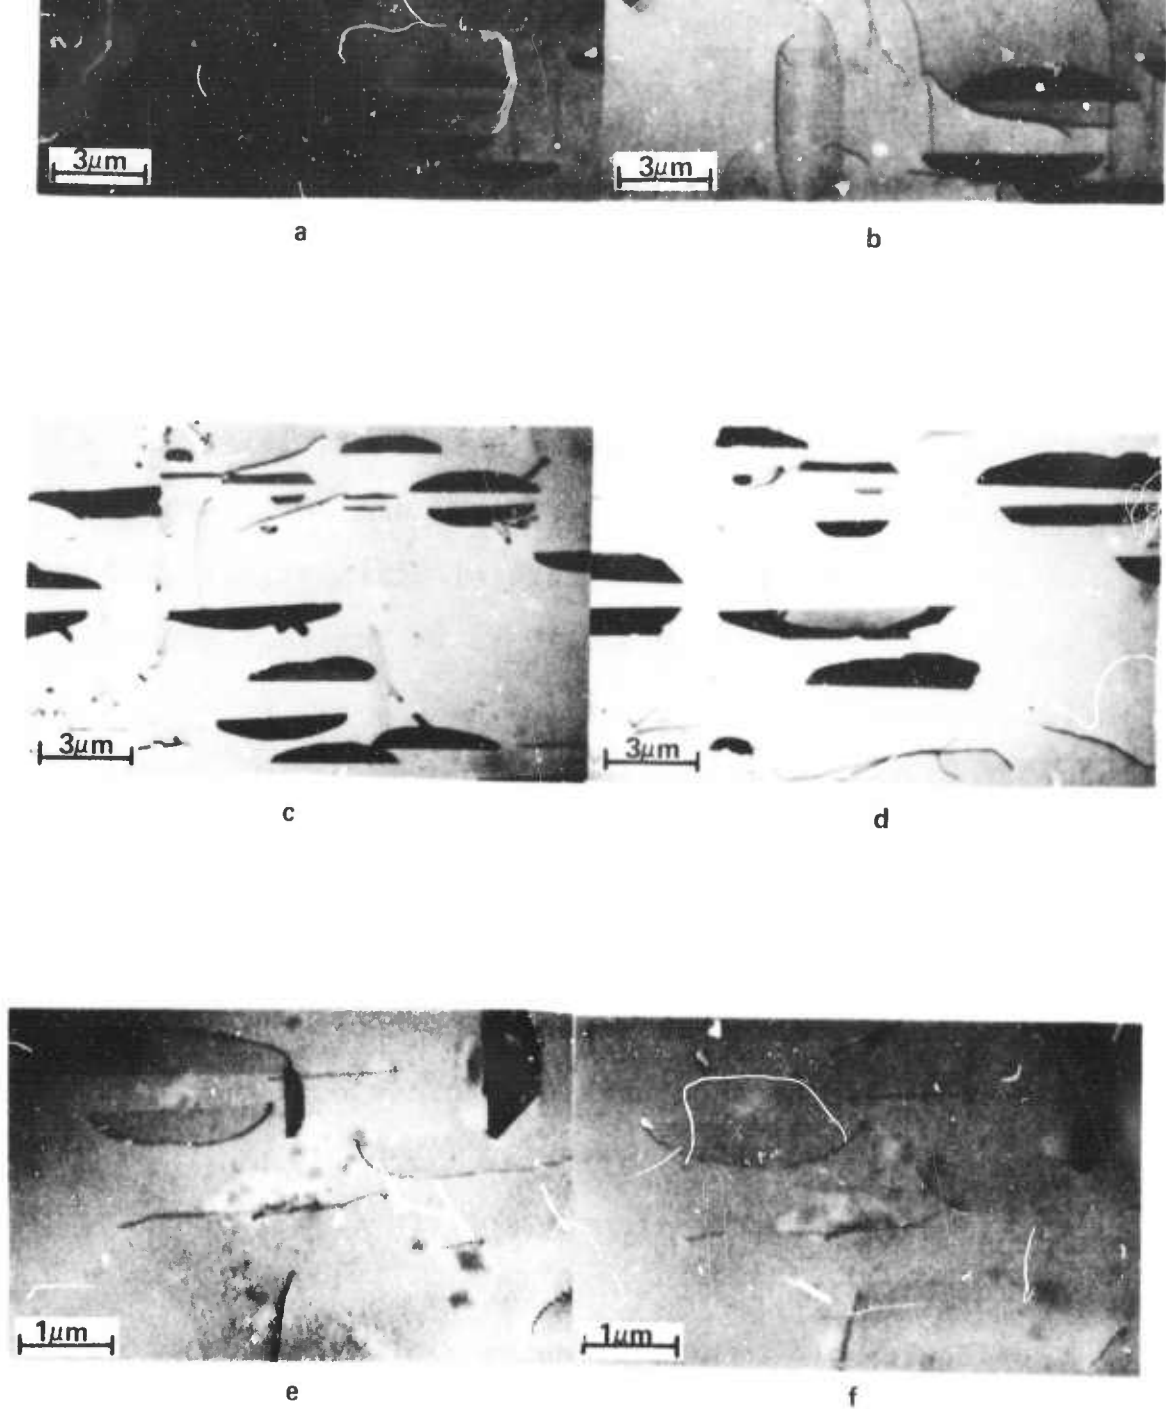
Fig. 24. TEM micrograph of a wafer surface. (a) (c) (e) After ISS and standard oxidation; and (b) (d) (f) after additional 10 min dry oxidation at 1050°C. Most of the stacking faults grow further. Some react and form perfect dislocations.

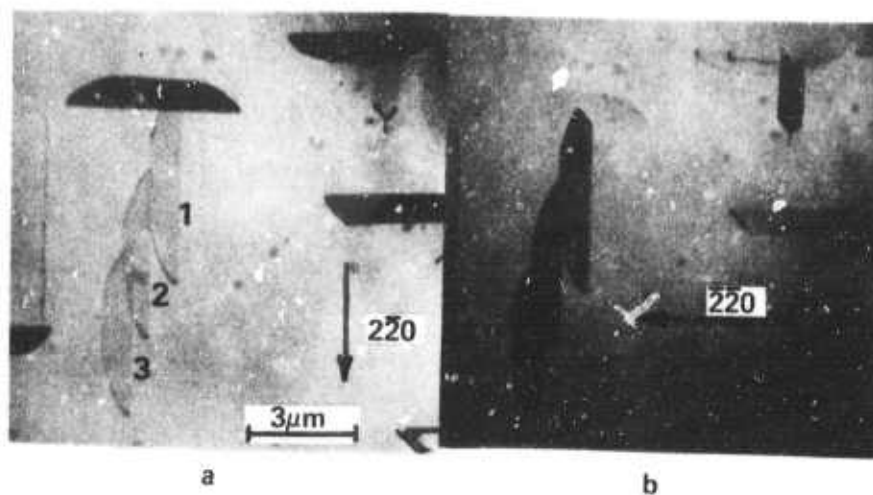
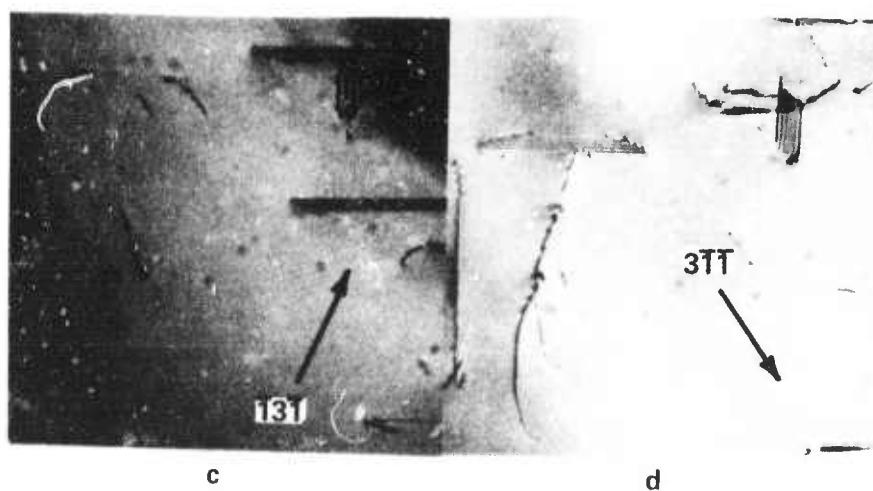
Fig. 25. TEM micrographs of oxidation stacking faults taken with (a) $2\bar{2}0$, (b) 220 , (c) $1\bar{3}\bar{1}$, (d) $3\bar{1}\bar{1}$ reflections.

Figure 25 shows some examples of TEM micrographs of the bounding dislocation of a stacking fault. Considering the values given in Table II and the contrast features shown in the micrographs (see stacking faults 1, 2, and 3 as marked in Fig. 25a), the conclusion is that the bounding dislocation

is an $a/3$ ($\overline{111}$) Frank partial. Each possible Shockley is excluded by a micrograph taken with one of the (113) reflections, e.g. Burgers vector (B.V.) $a/6$ $[112]$ is excluded by the $(\overline{1}3\overline{1})$ and $(3\overline{1}\overline{1})$ reflections (Fig. 25c,d); B.V. $a/6$ $[\overline{2}1\overline{1}]$ is excluded by (131) (Fig. 25e); and B.V. $a/6$ $[1\overline{2}\overline{1}]$ is excluded by (311) (Fig. 25f). Since contrast is seen for the dislocation line in all cited reflections the partial dislocation is identified as a Frank partial. In addition for $g.b = 0; \pm 1/3$ it can be observed that the line contrast is weak when the g-vector is more or less parallel to the line direction and that the line contrast is strong when the g-vector is perpendicular to it. It follows that for $(\overline{2}20)$, $(3\overline{11})$ and $(1\overline{3}1)$ reflections (Figs. 25e,f) assuming $b = a/3$ ($\overline{111}$), the line contrast is weak, if $g.(b \wedge u)$ is small, because $g.b = 0; \pm 1/3$, but that the line contrast is strong when $g.(b \wedge u)$ reaches larger values. This confirms again that the bounding partial dislocation is of the Frank type.
